# Failure Analysis: What Infrared Spectroscopy Can Tell You

by Dwight G. Weldon, Weldon Laboratories, Inc.

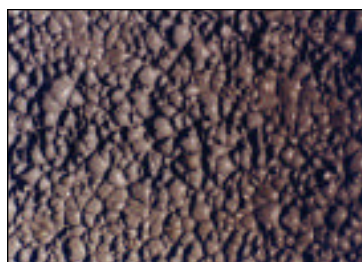
quire the use of the microscope, was that the back of the blistered coating was very rough. When examined microscopically, this roughness was due to an extensive “honeycomb” pattern in the urethane (Fig. 3).

The cell walls of the honeycomb were smooth and very glossy. Furthermore, examination of shavings removed from directly beneath a blister indicated the same type of honeycomb pattern in the gray urethane that had not lifted from the deck.

gested a reason: there appeared to be two coats of gray urethane, not the single coat called for in the specification. Furthermore, both coats were thicker than specified. The thickness of the honeycombed lower coat was difficult to judge because of the peaks and valleys of the honeycomb structure, but it averaged approximately 5 mils (125 micrometers). The upper urethane topcoat was 9–12 mils (225–300 micrometers) thick, compared to the specified value of 2–3 mils (50–75 micrometers).

Fig. 3: Back side of disbonded urethane topcoat showing dramatic honeycomb structure

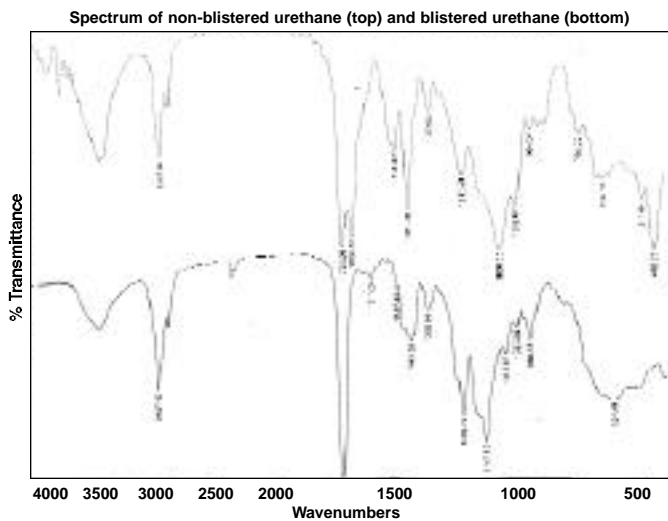
Figure 4 shows spectra of both the blistered, honeycombed urethane from a failed area and urethane topcoat from a non-blistered area. Even a cursory examination shows that the two spectra are considerably different. The spectrum of the non-failing coating is typical of a urethane, with characteristic bands near 1,725, 1,690, and 1,515  $\text{cm}^{-1}$ . To understand the origin of these bands, one must have knowledge not only of spectroscopy but also of urethane chemistry.

With this background information in mind, it is apparent that not only are the spectra of blistered and non-blistered urethanes different from one another, but also the blistered urethane is really not a urethane at all. If it were, it would have a strong band due to the urethane carbonyl group near 1,690  $\text{cm}^{-1}$ , as shown in the spectrum of the non-blistered topcoat. In fact, some additional laboratory work showed that the spectrum of the blistered “urethane” was quite similar to the spectrum of the Part A component of the coating (the acrylic polyol component), without the addition of any of the Part B isocyanate component.

In summary, it is apparent that the blistering of the coating system occurred in the few hundred square foot area because the contractor simply applied the Part A component of the two-component urethane, without mixing it with the Part B isocyanate component. The coating never cured because there was nothing for the acrylic polyol resin to react with. It is possible that the contractor realized this, since the topcoat was probably soft or sticky, and tried to fix it by applying a second coat of properly mixed urethane. This would explain why there were two coats of topcoat in the blistered area, rather than the specified single coat. Unfortunately, rather than fixing it, this “solution” just caused a different type of problem. The uncured, solvent-sensitive acrylic resin was partially redissolved by the solvents in the second, very thick coat (9–12 mils [225–300 micrometers] vs. the speci-

Fig. 4: Infrared spectra of non-blistered urethane (top) and blistered urethane (bottom)

fied 2–3 mils [50–75 micrometers]), and it ruptured when this second coat cured and shrank. (All coatings shrink somewhat upon curing, imparting stress to lower layers.) The redissolving and rupturing of the first coat of “urethane” caused the formation of the honeycomb pattern and the blisters.

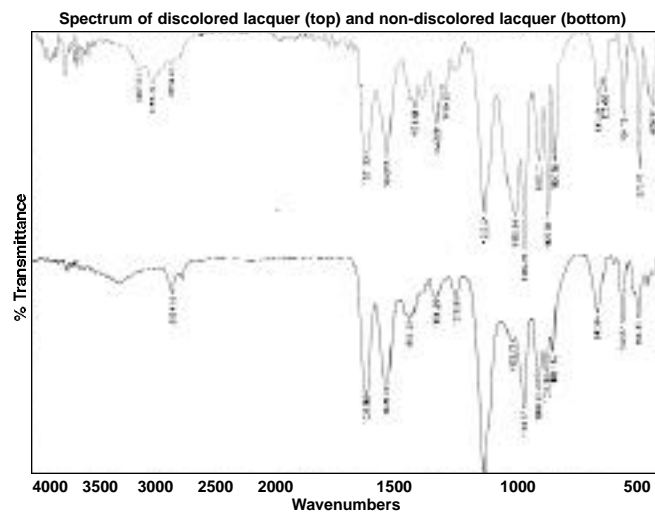
Fig. 5: Infrared spectra of discolored lacquer (top) and non-discolored lacquer (bottom)

Spectra were obtained of both discolored and non-discolored lacquer (Fig. 5). The spectrum of the non-discolored lacquer is rather complicated, but it is consistent with a coating consisting of an alkyd resin and a urea formaldehyde resin, which is a common recipe for a catalyzed or “conversion” varnish. These two resin types react upon the addition of a catalyst, often aided by a low-temperature bake.

An examination of the two spectra in Fig. 5 shows that there are marked differences between the discolored and non-discolored lacquers. The discolored sample has additional bands near 3,170, 3,060, 1,450, 1,150, and 1,025  $\text{cm}^{-1}$ .

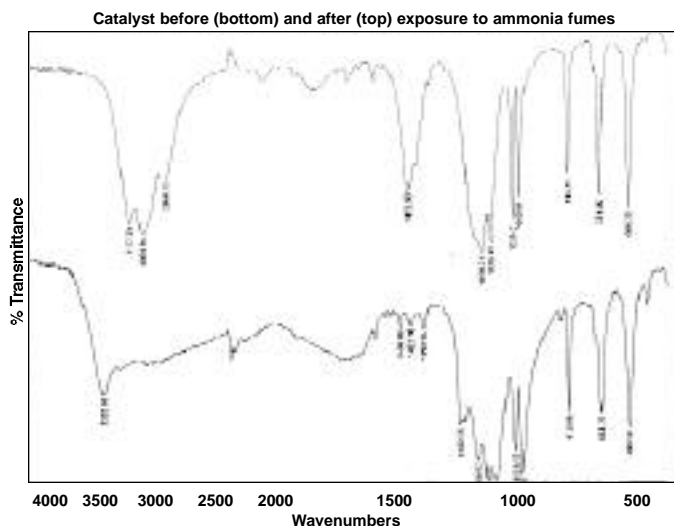
Fig. 6: Infrared spectra of catalyst before (bottom) and after (top) exposure to ammonia fumes

Figure 6 is the spectra of the catalyst component that was applied to a glass slide and allowed to dry, obtained both before and after exposure to ammonia fumes. The exposure to ammonia fumes resulted in dramatic changes to the spectrum, which included the appearance of strong bands near 3,170, 3,060, 1,450, and 1,150  $\text{cm}^{-1}$ , the same locations of the “new” bands in the spectrum of the discolored lacquer. Furthermore, after exposure to the ammonia fumes, the catalyst changed from a clear material to a white material.

Based on the above observations and testing, the lacquer developed the milky white discoloration because of a reaction between the pTSA catalyst added to the lacquer and ammonia or an ammonia-based glass cleaner used by the office cleaning staff. Although it would take a fair amount of additional work to prove, it seemed likely that the catalyst was either added in excess or was not evenly distributed throughout the lacquer, and that the problem occurred in catalyst-rich areas.
